## FOR REPAIRING CABLE JACKETS OF MINE- POWER- AND COMMUNICATION CABLES WITH DOUBLE LAYER MASTIC

### GENERAL DESCRIPTION

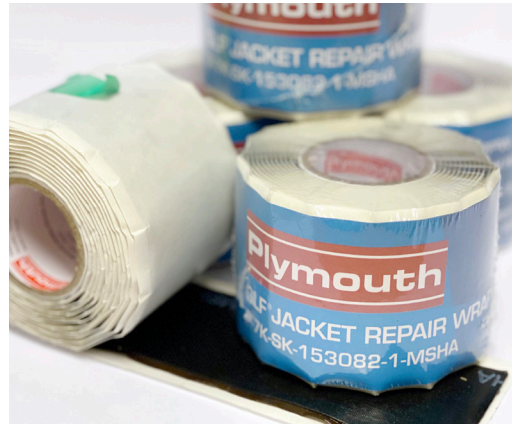
GLF 2 Jacket Repair Wrap is a unique laminate of a specially formulated Hypalon backing and a flame retardant 2-layer mastic possessing the superior abrasion and moisture resistance required for all types of cable jacket repair. The laminate is easy to apply and remains flexible at low temperatures. GLF 2 will adhere to all types of cable jackets yielding a positive moisture seal. GLF 2 bears the acceptance no. P-7K-SK-153082-1-MSHA.
